## ENGINEERING INVESTIGATION REPORT

### **STEPHANIE AND MICHAEL WADSWORTH v. WALMART, INC. AND JETSON ELECTRIC BIKES, LLC**

Case No.: 2:23-CV-00118  
Location: 1620 Highway 374, Green River, Wyoming  
Date of Loss: February 1, 2022  
AEI Project No.: 15082

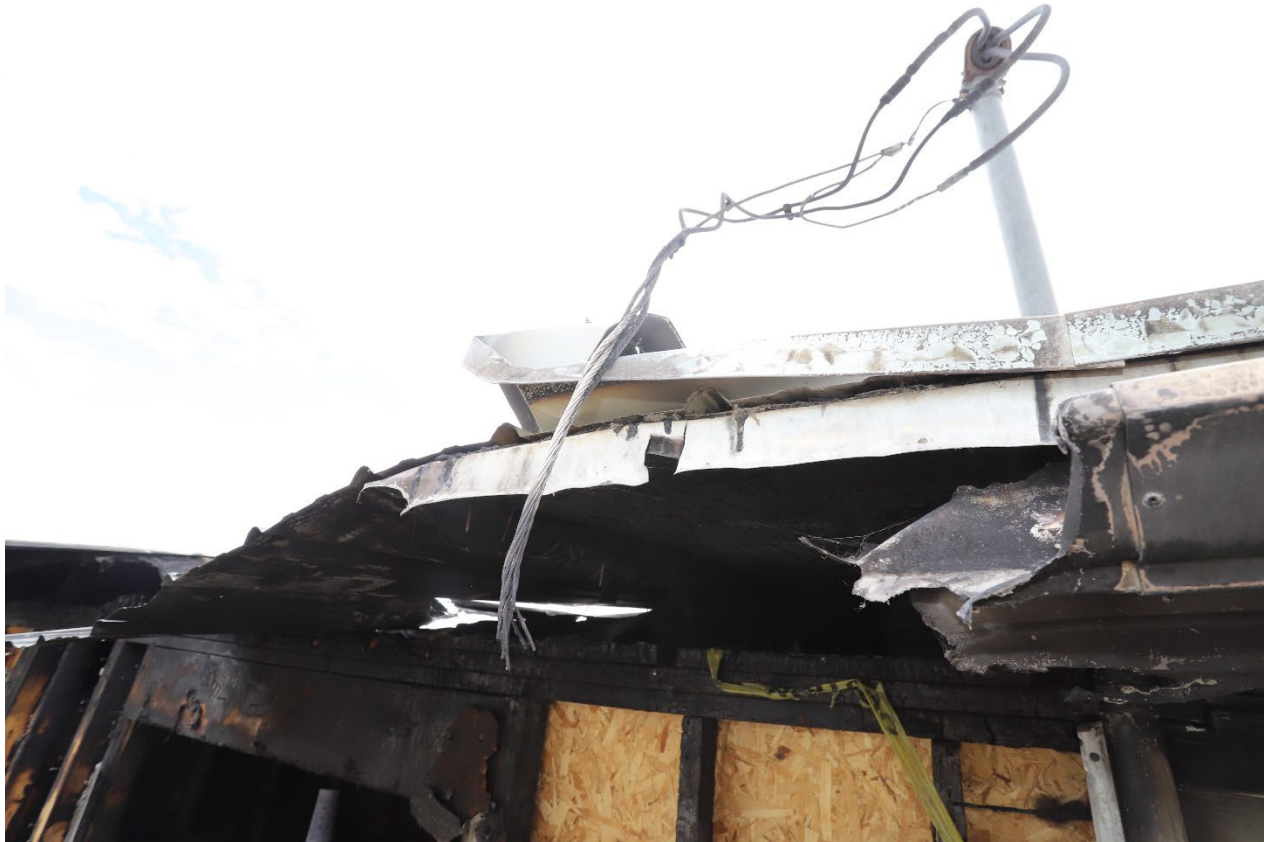
The joint site inspection was continued on August 2 and 3, 2022, with additional parties represented. Electrical service to the Residence was provided via an overhead service triplex from a utility pole located to the southeast of the Residence to a weatherhead and meter base located just south of the front door on the east exposure. The service triplex was severed several feet prior to where it connected to the weatherhead (Figure 2). The severed ends of the aluminum conductors comprising the service triplex had been melted. The weatherhead was located to the north of the remnants of the Smoking Shed and adjacent to an area of the roof that was consumed in the fire; however, there was no direct fire damage to the weatherhead or the meter base. In its installed position, the service triplex would have ran directly over the Smoking Shed.

**Figure 2. Weatherhead and severed service triplex (15082 BNS 2-221).**

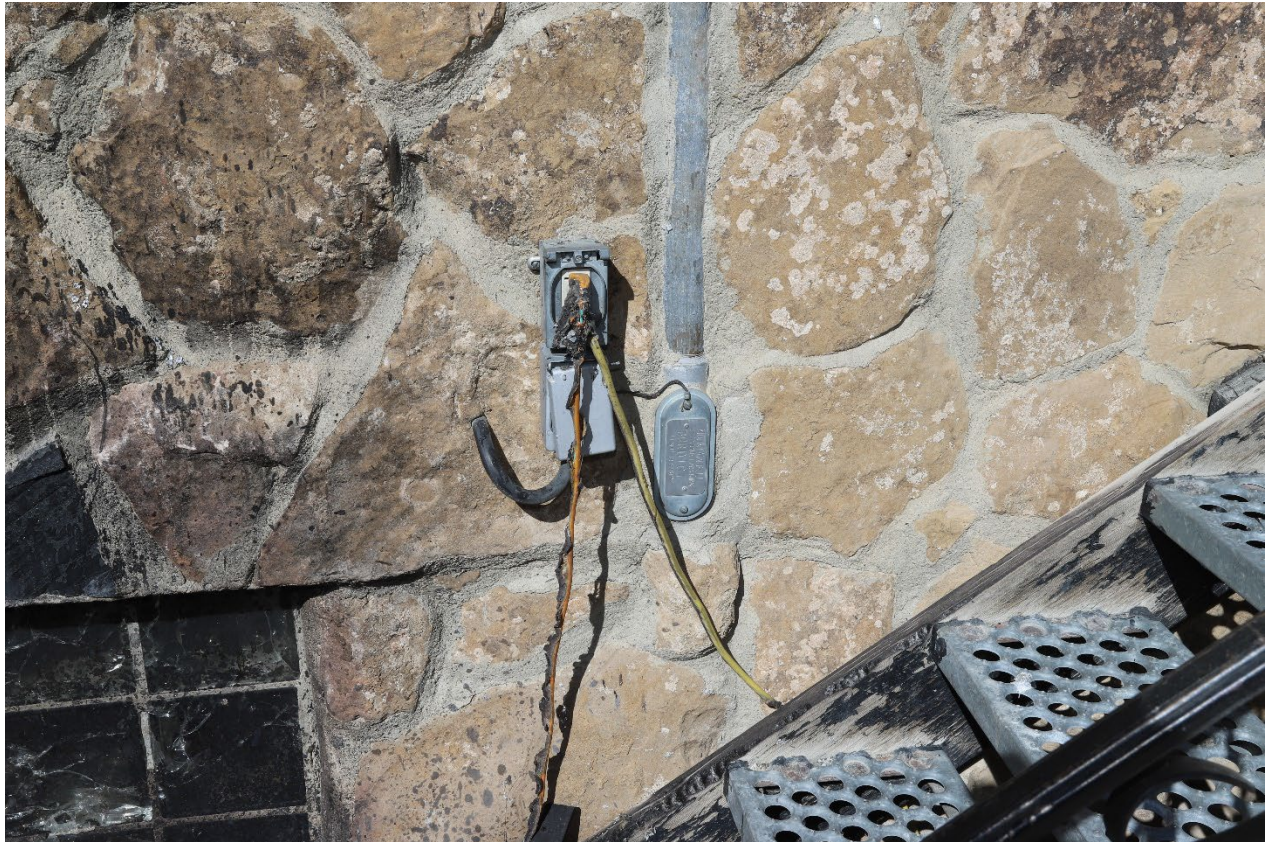
The main electrical panel was located in the basement below the meter base. There was no direct fire damage to the main panel or the area of the basement in which it was installed. A single-pole, 15-ampere, branch circuit breaker in position 1 (labeled “North west Bedroom”) in the main panel fed the receptacles and luminaires in Bedroom #4. A two-pole, 30-ampere, branch circuit breaker installed in positions 16 and 18 (labeled “Outside Porch Power”) in the main panel fed a NEMA 10-50R receptacle and a duplex NEMA 5-15R receptacle on the east exterior of the Residence via an 8/3 SO cord (Figure 3).

**Figure 3. A NEMA 10-50R receptacle and a duplex NEMA 5-15R receptacle on the east exterior of the Residence. Two extension cords are plugged into the duplex receptacle (15082 BNS 1-032).**

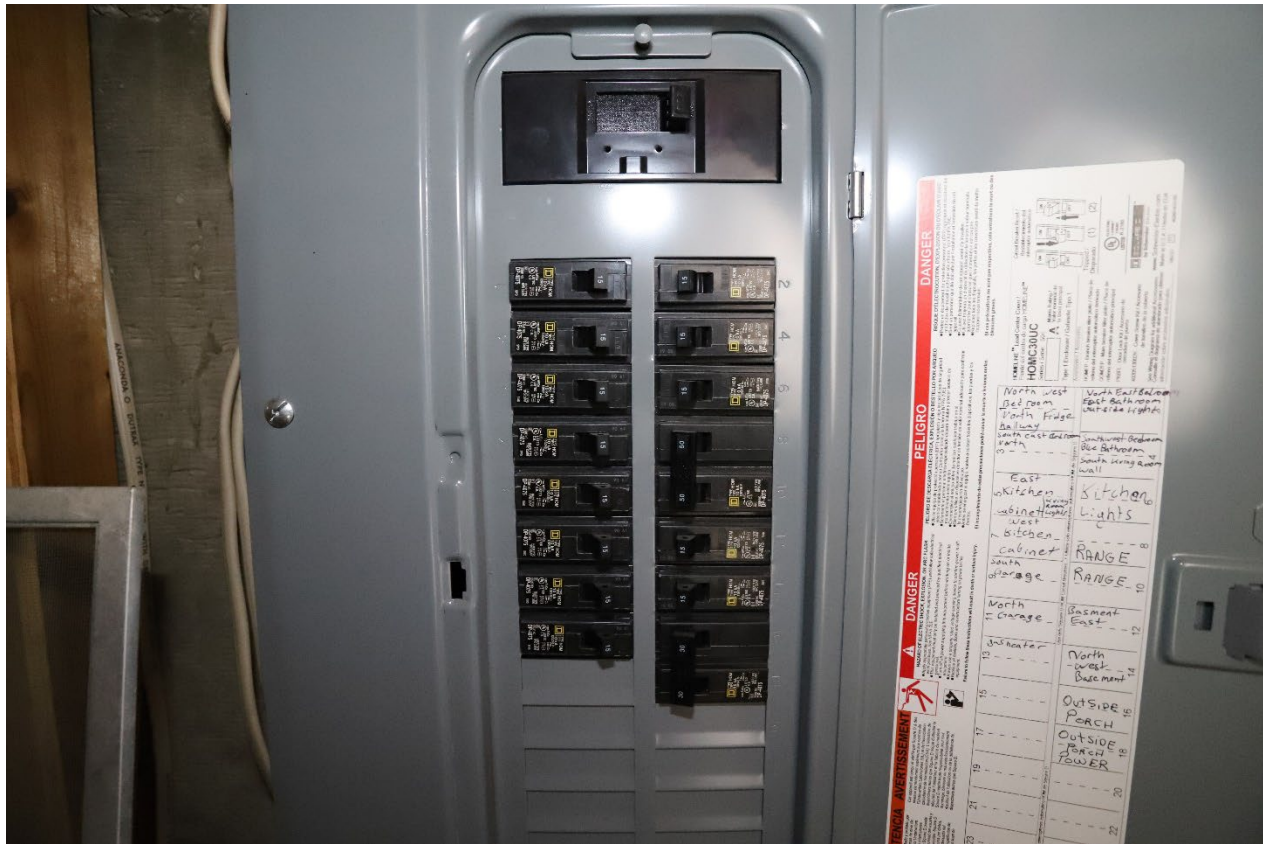
Both the main circuit breaker and all of the branch circuit breakers were standard thermal-magnetic circuit breakers without ground fault circuit interruption (GFCI) or arc fault circuit interruption (AFCI) capability. All of the circuit breakers in the main panel were in the 'ON' position (Figure 4). No circuit breakers were found in the tripped position; however, during removal from the main panel the circuit breaker in position 1 was accidentally dropped which caused it to trip.

**Figure 4. Main electrical panel (15082 BNS 1-125).**

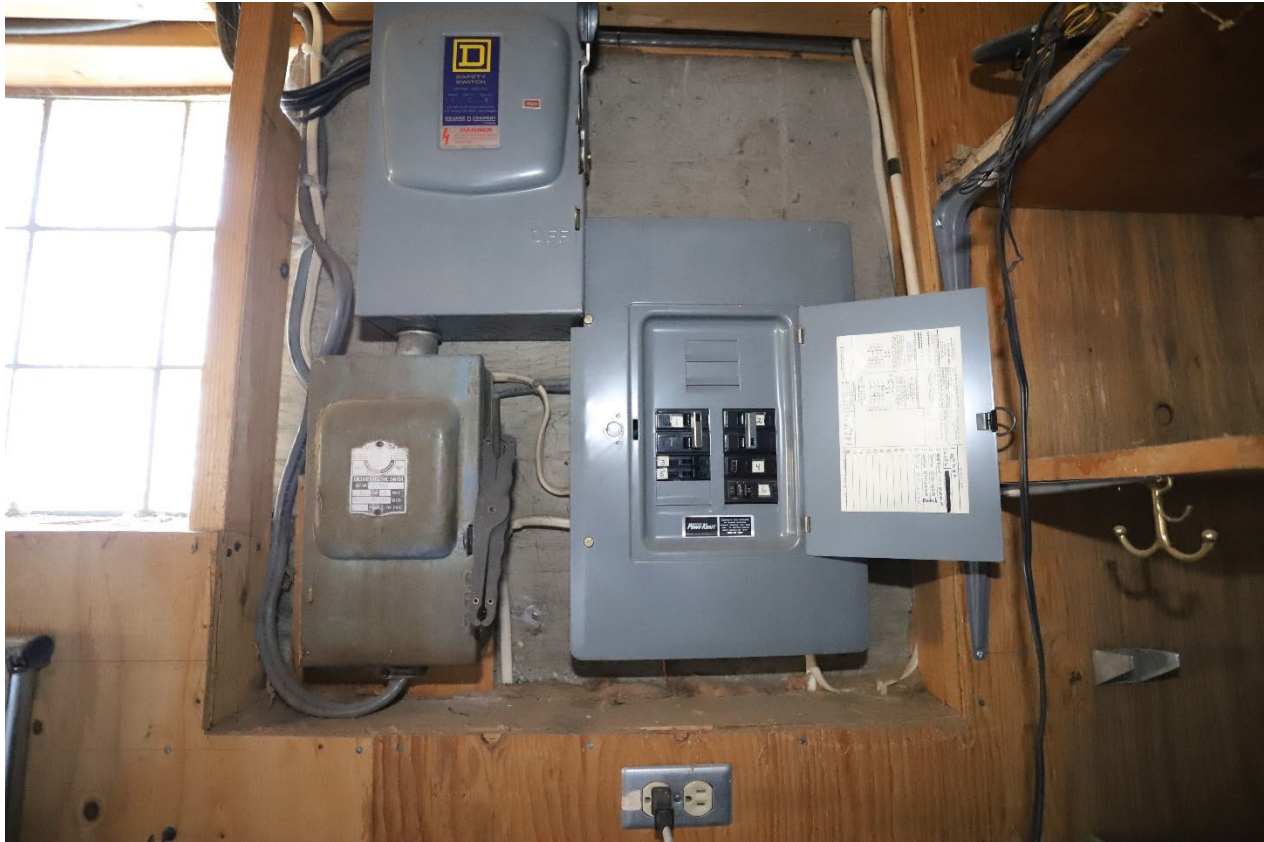
An electrical sub-panel was present on the west interior wall of the basement (Figure 5). The panel was not fire damaged and was labeled as serving areas of the Residence that were not fire damaged. The sub-panel was not preserved for further examination.

**Figure 5. Electrical sub-panel (15082 BNS 1-099).**

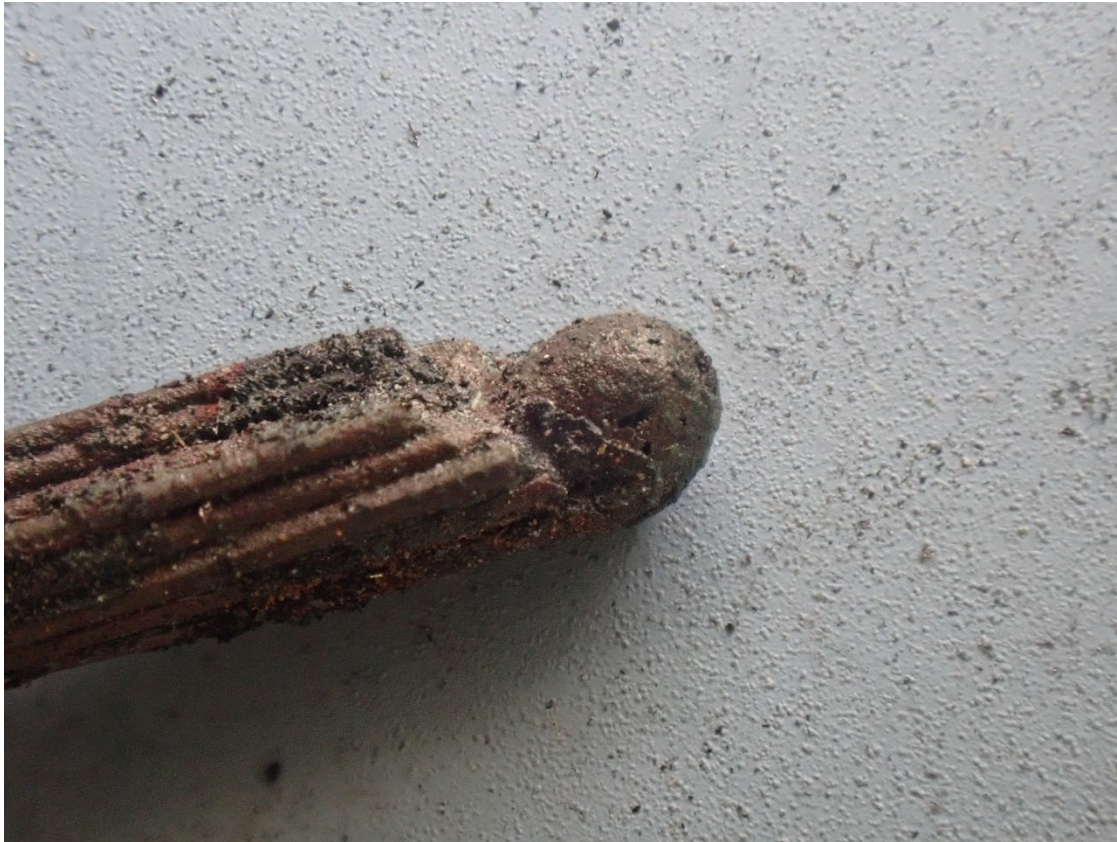
Two extension cords (one orange and one yellow in color) were plugged into the duplex receptacle on the east exterior of the Residence. The yellow extension cord ran to a metal post approximately 20 feet to the east of the Residence where it was connected to a splitter. Plugged into the splitter was a cord leading to an electrical box mounted on the post, a shore power cord for a camper trailer parked near the post and a second yellow extension cord which fed a bird bath de-icer in a polymer barrel of water located to the south of the remnants of the Smoking Shed on the east exterior of the Residence. The orange extension cord ran to the melted and resolidified mass of polymer in the location where the Smoking Shed once stood. Fragments of stranded copper conductors were present in and around the remnants of the Smoking Shed, some displaying visual evidence of electrical arcing (Figure 6). The remnants of the Smoking Shed and surrounding debris were preserved for further examination.

**Figure 6. Evidence of electrical arcing on conductor found outside structure at Smoking Shed (15082 BNS 3-006).**

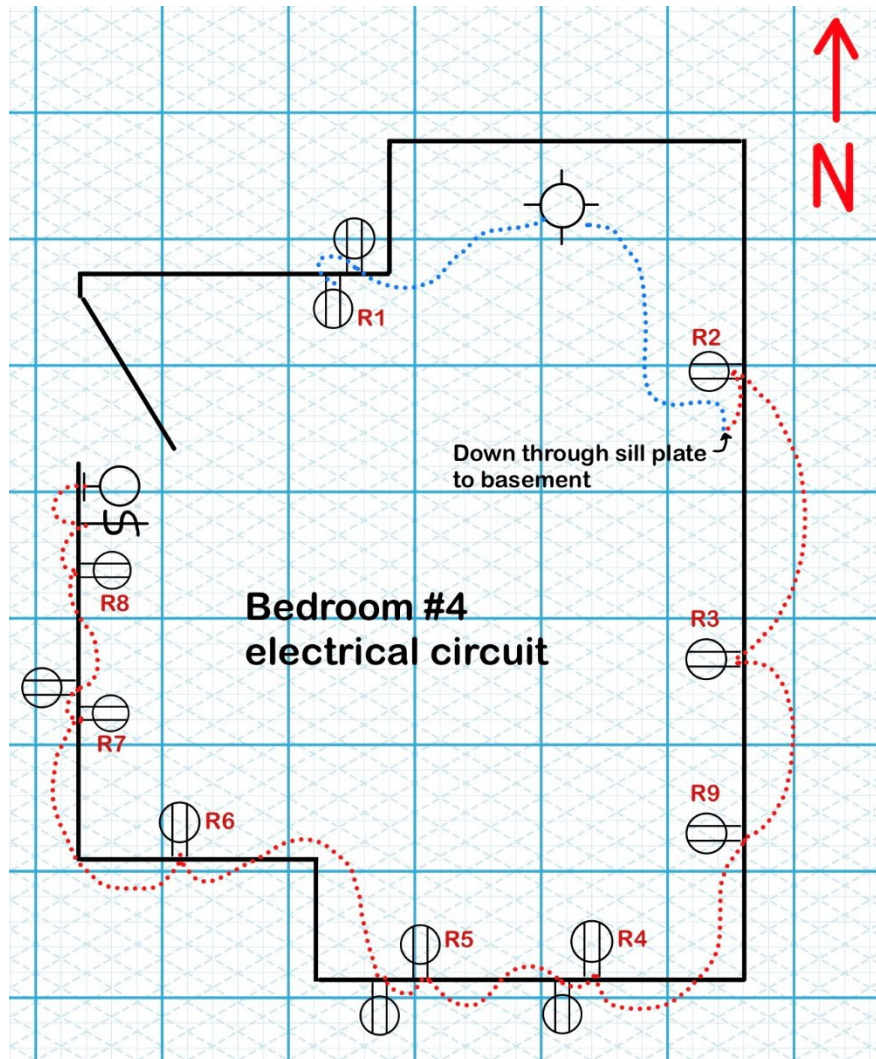
The entire branch circuit from within Bedroom #4 was traced and preserved for further examination. The branch circuit that supplied power to Bedroom #4 was split into two separate non-metallic (NM) cables in the basement of the Residence. These two NM cables were marked with red and blue paint respectively at the locations where they were cut in the basement of the Residence during the collection of artifacts during the joint scene inspection. The NM cable marked with blue paint fed the northern portion of Bedroom #4 and the NM cable marked with red paint fed the southern portion of the room. The duplex receptacles in Bedroom #4 were designated R1 through R9 during the joint site inspection prior to removal from the structure (Figure 7).

**Figure 7. Diagram of the electrical branch circuit in Bedroom #4.**

The red painted NM cable ran up through the sill plate from the basement into Bedroom #4 where it connected to R2. The electrical insulation on the NM cable was largely intact in this segment of the branch circuit with some discoloration and charring of the cable jacket. The NM cable connecting R2 to R3 was entirely consumed by the fire along several feet of the cable with the remaining portion of the segment charred. Most of the insulation on the segment of the branch cable between R3 and R9 was entirely consumed by the fire. While some portions of the NM cable between R9 and R4 contained intact insulation, the insulation on several feet of the segment were entirely consumed by the fire. The branch circuit continued from R4 to a duplex receptacle for an adjacent room (Bedroom #1), then to R5, and to another duplex receptacle for an adjacent room (Bedroom #1). This segment of NM cable contained intact insulation. The circuit continued to R6 with mostly intact but charred insulation of the NM cable. From

R6 to R7 the insulation on the NM cable was entirely consumed by the fire over several feet of its length. The branch circuit continued from R7 to another duplex receptacle from an adjacent room (hallway), with intact insulation. The NM cable continued to R8, a wall switch, and a wall sconce all located next to the door to Bedroom #4. The insulation on this last section of the NM cable was almost entirely consumed by the fire.

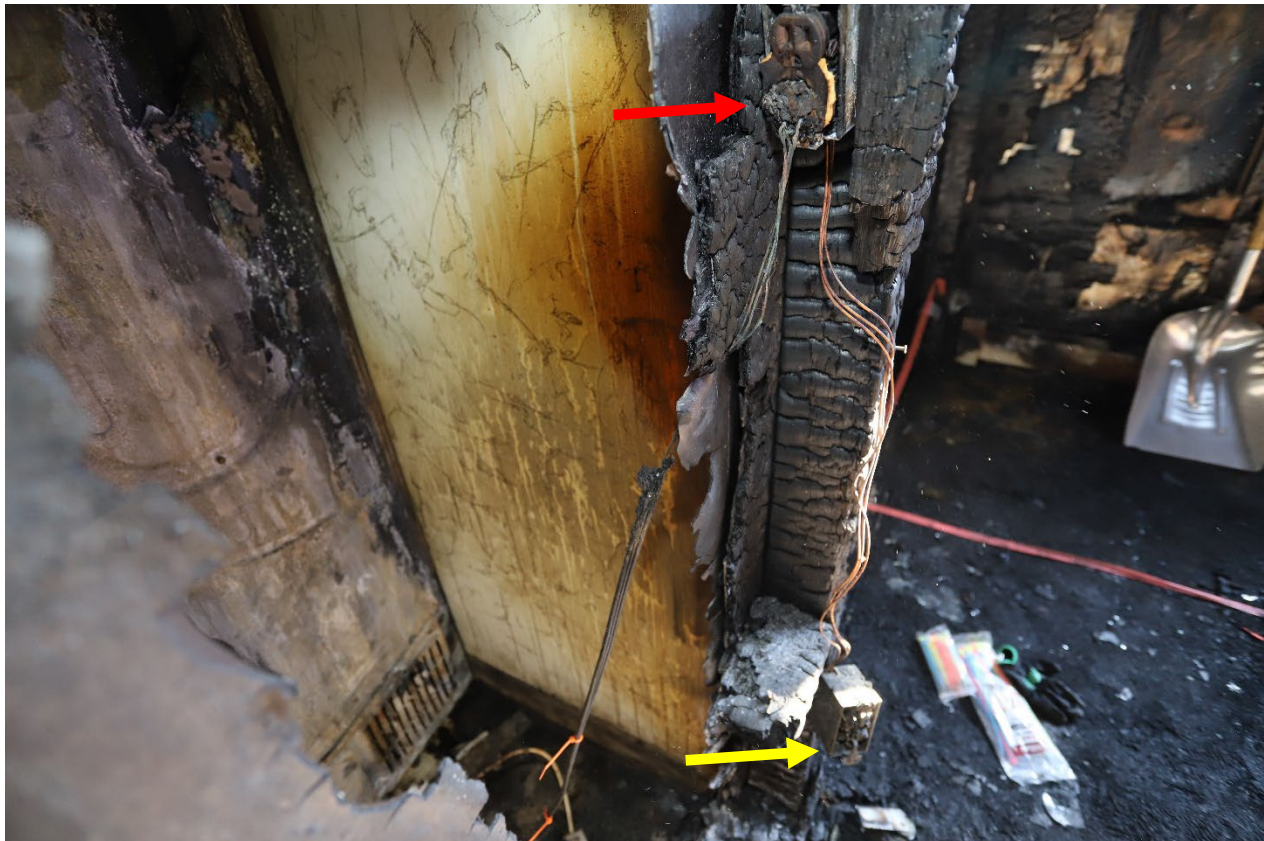
The blue painted NM cable ran up through the sill plate from the basement into Bedroom #4 near the location of the red painted NM cable. The blue painted NM cable ran to a ceiling mounted luminaire in the closet of Bedroom #4, then to a duplex receptacle in an adjacent room (kitchen, refrigerator receptacle), and then to R1. The insulation on this section of the branch circuit was entirely consumed by the fire. The power cord from the refrigerator in the kitchen was still plugged into its receptacle, there were no conductors plugged into receptacle R1 (Figure 8). The subject hoverboard was reportedly found on the floor in the area of receptacle R1.

**Figure 8. Power cord for refrigerator plugged into receptacle (red arrow), and receptacle R1 with no cords plugged in (yellow arrow) (15082 BNS 4-035).**

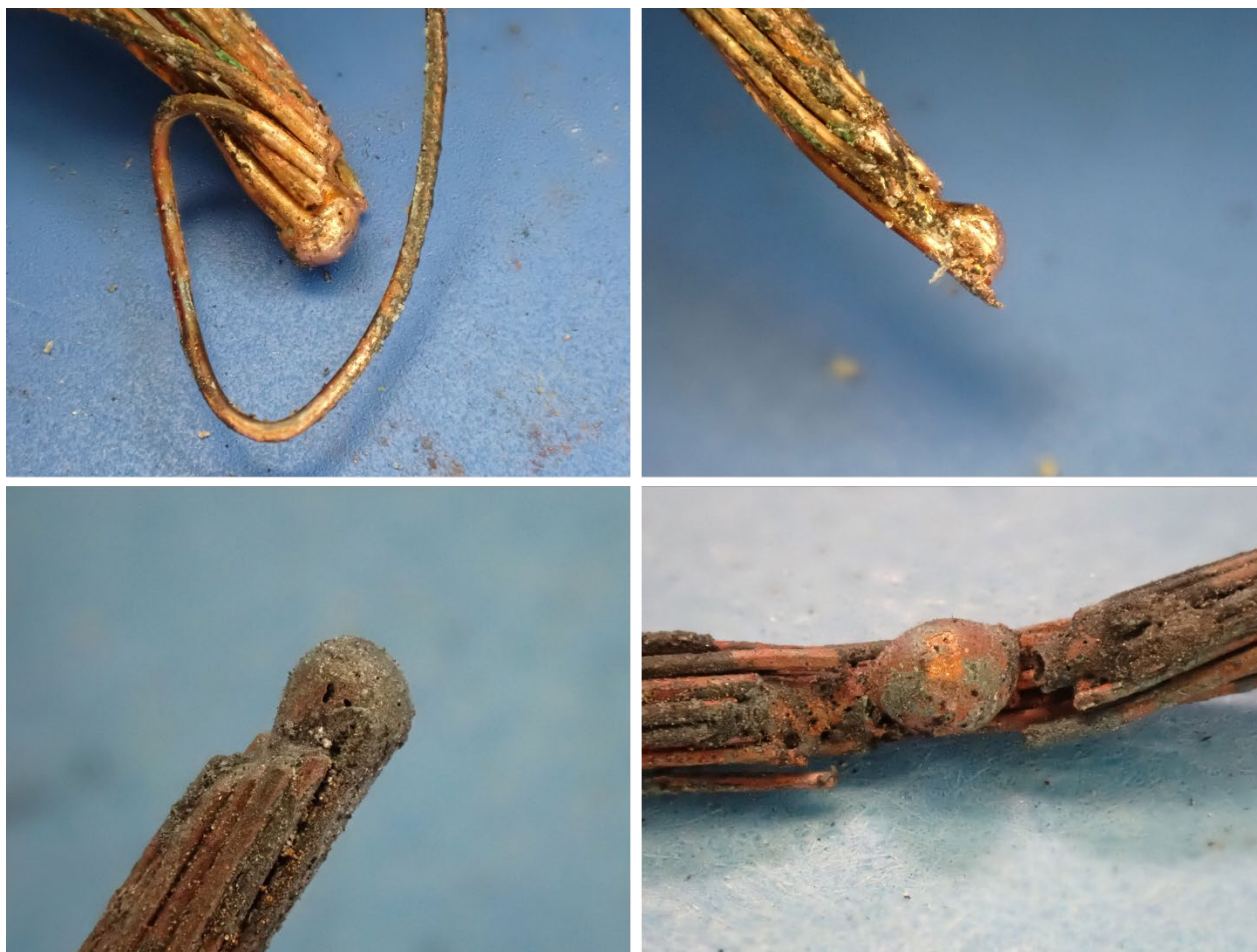
A laboratory examination of the artifacts preserved from the fire scene was conducted at the Palmer Engineering and Forensics facility in North Salt Lake City, Utah on October 30 and 31, 2023. Debris collected from the exterior of the Residence in the area of the Smoking Shed including the mass of melted and resolidified polymer that remained of the Smoking Shed was examined. Numerous stranded copper conductor fragments were found that contained evidence of electrical arcing (Figure 9).

**Figure 9. Some of the instances of evidence of electrical arcing on conductors found in or around the Smoking Shed (15082 BNS 7-014, 7-106, 7-045, 7-066).**

In the subject fire, stranded copper conductors present in the Smoking Shed, either extension cords or appliance (space heater) cords, or both, displayed evidence of electrical arcing proving that those cords were energized at the time that fire was present in the Smoking Shed. The entire branch circuit that supplied power to the receptacles and luminaires in Bedroom #4; however, contained no evidence of electrical arcing despite the electrical insulation being completely burned away on portions of the circuit. The insulation on the branch circuit wiring to the receptacle immediately adjacent to the location where the hoverboard was found was completely consumed in the fire; however, there was no evidence of electrical arcing on these conductors. The lack of any evidence of electrical arcing occurring in the fire damaged branch circuit conductors located in Bedroom #4 and the lack of any tripped circuit breakers in the electrical panel for the Residence (including the branch circuit breaker for Bedroom #4) was consistent with the branch circuit supplying power to Bedroom #4 being de-energized at the time that the fire attacked the branch circuit conductors in the bedroom.

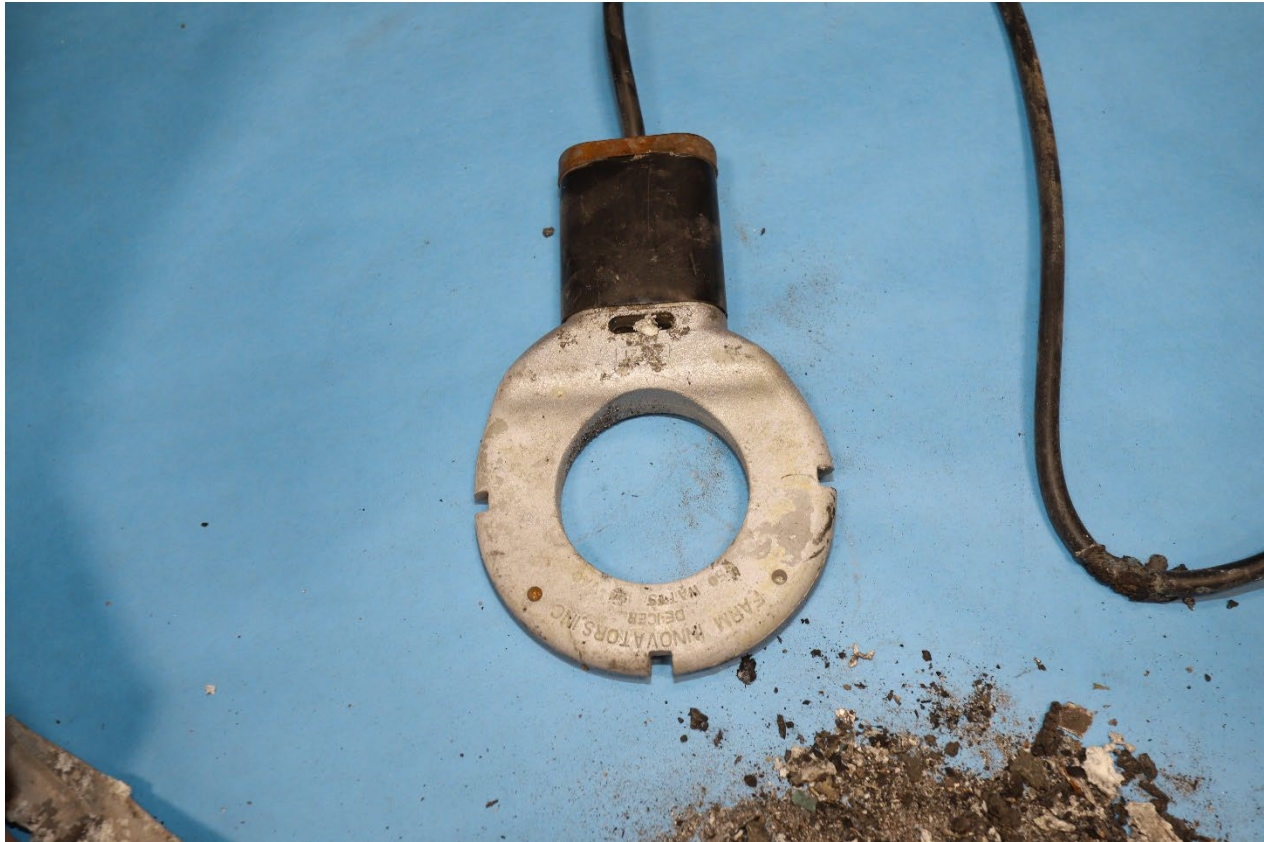
The power cord for bird bath de-icer and the yellow jacketed extension cord it was plugged into were both thermally damaged in the area where the cords were located near the Smoking Shed. The body of the bird bath de-icer was intact and not fire damaged (Figure 10). There was no evidence of a failure of the bird bath de-icer.

**Figure 10. Bird bath de-icer not fire damaged (15082 BNS 5-054).**

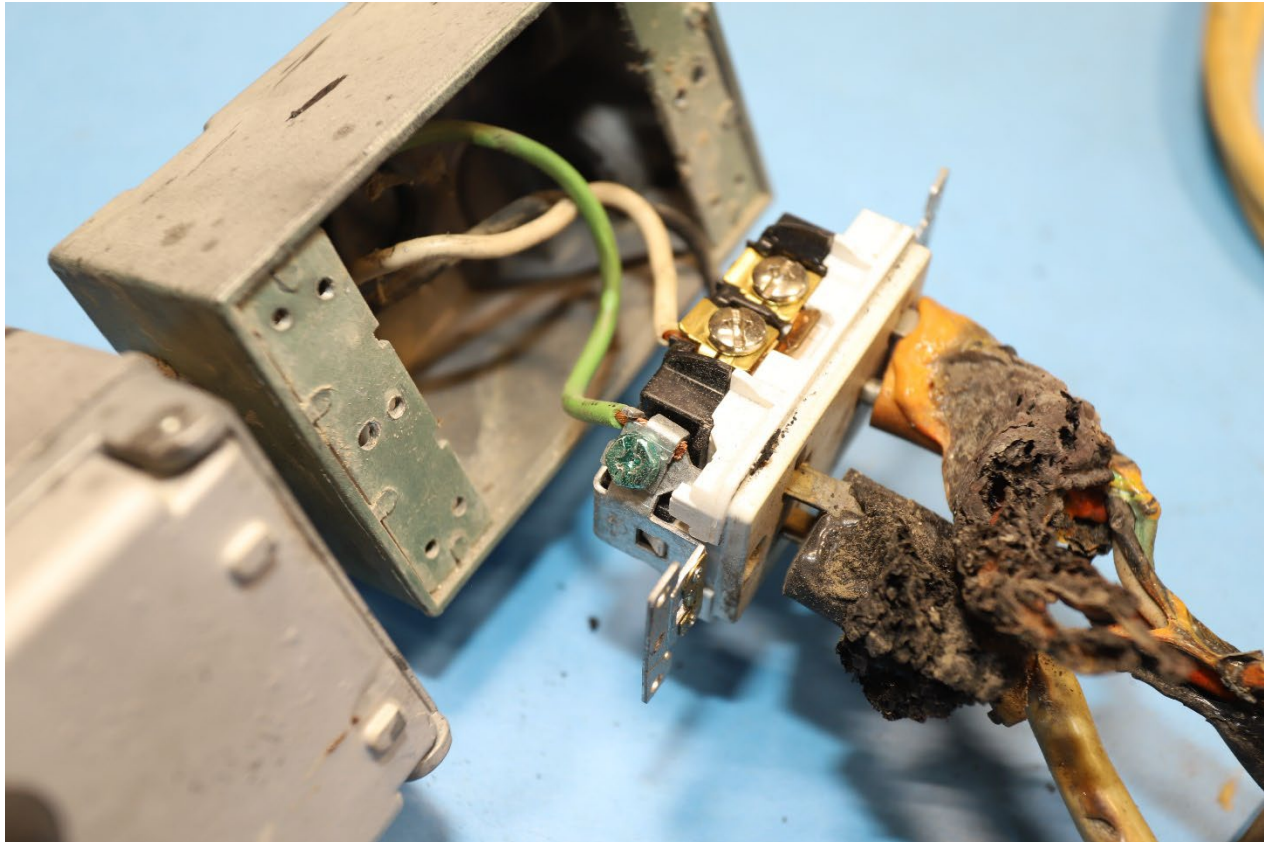
The 50-ampere and duplex 20-ampere receptacle from the east exterior of the Residence were opened for examination. The 50-ampere receptacle was fed by an 8-gauge, 3 conductor (8/3), type SO cord from a two-pole, 30-ampere, branch circuit breaker in the main panel. The duplex 20-ampere receptacle was fed by smaller gauge conductors tapped into the screw terminals on the 50-ampere receptacle. The grounding tab on the duplex receptacle was wired to the metal switch box that housed the receptacle and an uninsulated stranded conductor exited the switch box through a drilled hole. The other end of the uninsulated conductor had been bolted to a metal conduit connected to the meter base at the Residence. Neither of the receptacles were fire damaged. Two extension cords, a (second) yellow jacketed cord, and an orange jacketed cord were plugged into the duplex receptacle (Figure 11). The extension cord jackets and the plug ends were thermally damaged from the outside. There was no evidence of a failure at the receptacles.

**Figure 11. Two extension cords plugged into the duplex receptacle on the east exterior of the Residence (15082 BNS 5-099).**

The 20-ampere, duplex receptacle on the east exterior of the Residence was tapped off of a 30-ampere branch circuit. The extension cords plugged into the duplex receptacle that ran to the Smoking Shed were a combined length of approximately 50 feet or more in length and constructed of stranded copper conductors that were far smaller than required for service on a 30-ampere branch circuit. The overcurrent resulting from electrical arcing at or near the far end of those long, smaller conductors would be limited by the impedance of the circuit and the 30-ampere branch circuit breaker could not be expected to reliably trip when that arcing occurred.

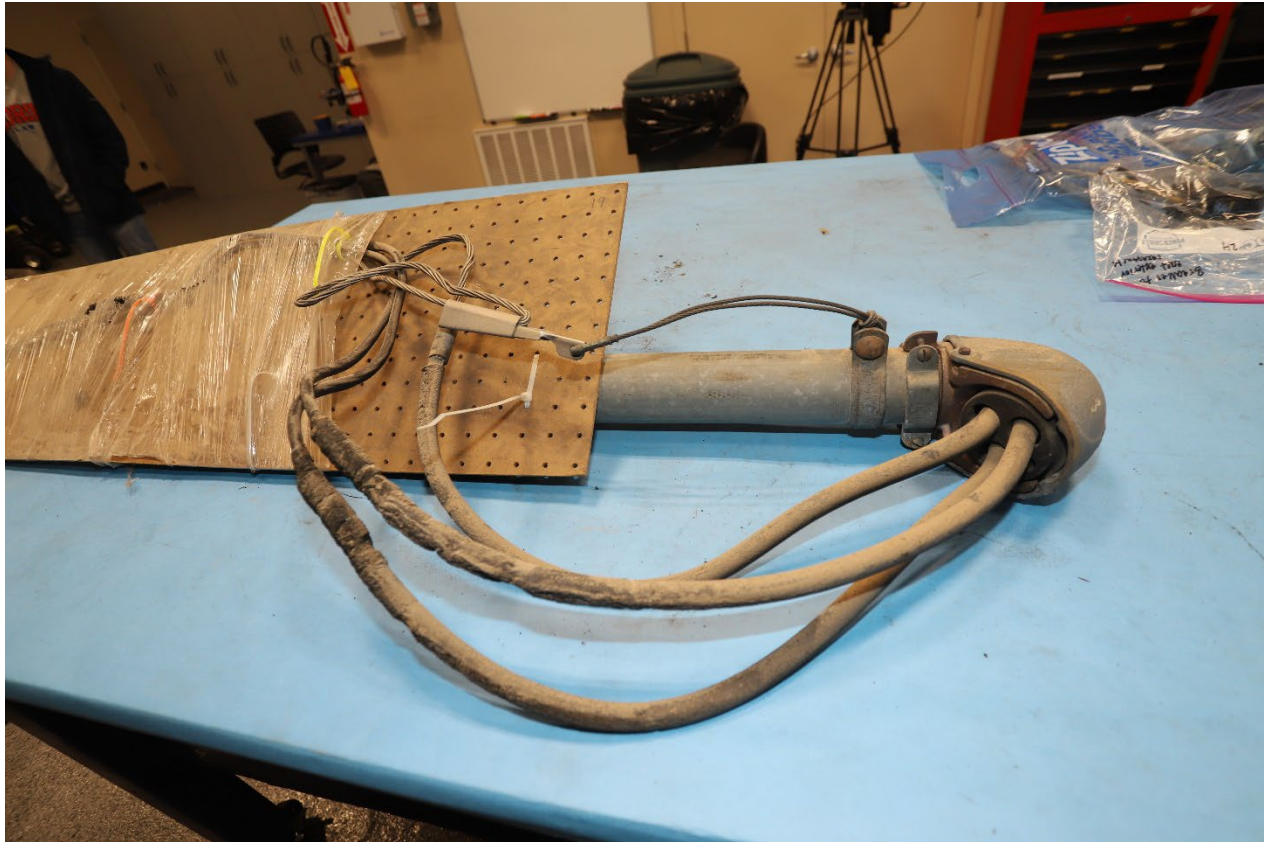
The weatherhead and remnants of the service triplex were examined (Figure 12). The weatherhead was not fire damaged. Thermal damage was present on the insulation on the individual service entrance conductors near the connections to the service triplex conductors. The service triplex conductors were melted and severed several feet from the connection point to the service entrance conductors to the Residence in the area that would have been overhead of the location of the Smoking Shed.

**Figure 12. Weatherhead not fire damaged (15082 BNS 5-266).**

The aluminum conductors of the service triplex supplying electrical power to the Residence were melted and severed during the fire in the area where the service triplex ran directly overhead of the Smoking Shed. Copper electrical conductors are composed of essentially pure copper which has a melting temperature of approximately 1,983 °F. Aluminum electrical conductors used to construct a service triplex are typically composed of an aluminum alloy which has a melting temperature of approximately 1,200 °F. Unlike copper conductors which often survive a structure fire, aluminum conductors such as the subject service triplex will often melt when exposed to a fire due to the lower melting temperature of aluminum. When the aluminum service triplex conductors were severed by the fire, the entire electrical system in the Residence was de-energized. This included all of the branch circuits within the Residence and all of the extension cords plugged into the duplex receptacle on the exterior of the Residence.

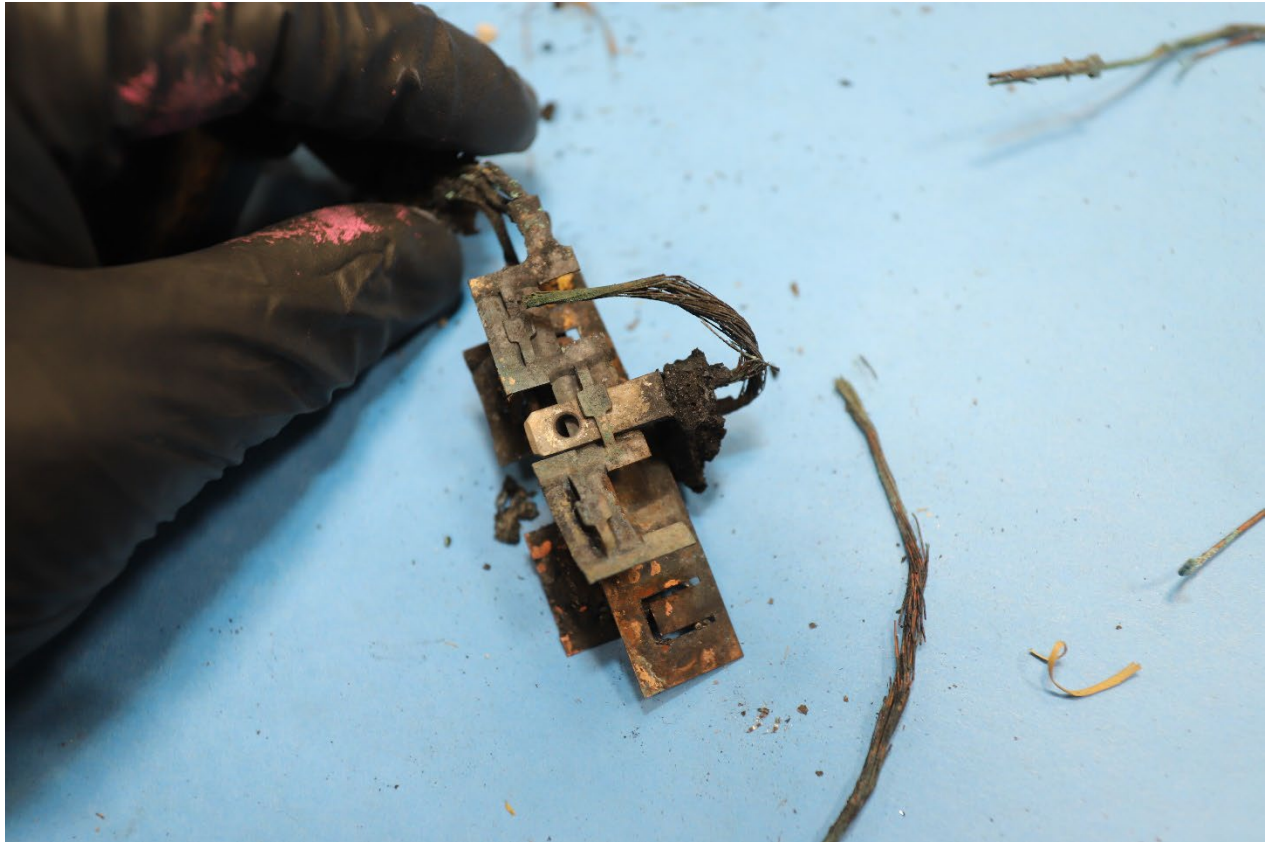
A three-position power tap from the end of an extension cord with two plug blades present in one of the positions recovered from the area of the Smoking Shed was examined (Figure 13). There was no evidence of electrical arcing at the plug connections nor any other evidence of a failure of the connections. The stranded copper conductors of the power tap were mechanically fractured several inches from the receptacle.

**Figure 13. Three position power tap from the end of an extension cord with two plug blades from an unknown device still attached (15082 BNS 5-129).**

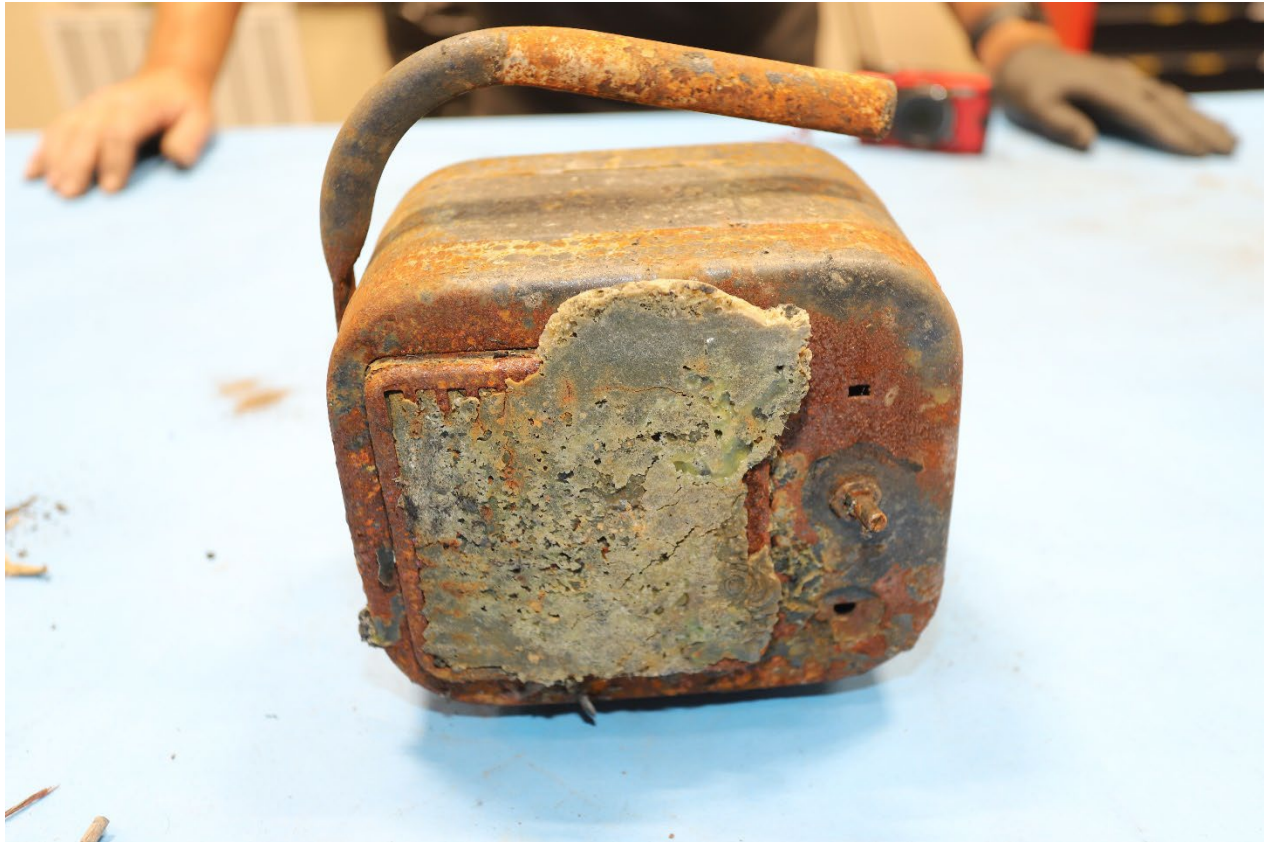
The fire damaged remnants of a fire damaged electric space heater found in the area of the Smoking Shed were externally examined (Figure 14). The conductors of the power cord were fractured at the location where they entered the body of the heater. A melted and resolidified mass of polymer filled the air outlet of the space heater. No destructive examination of the space heater was performed.

**Figure 14. Fire damaged space heater (15082 BNS 5-129).**

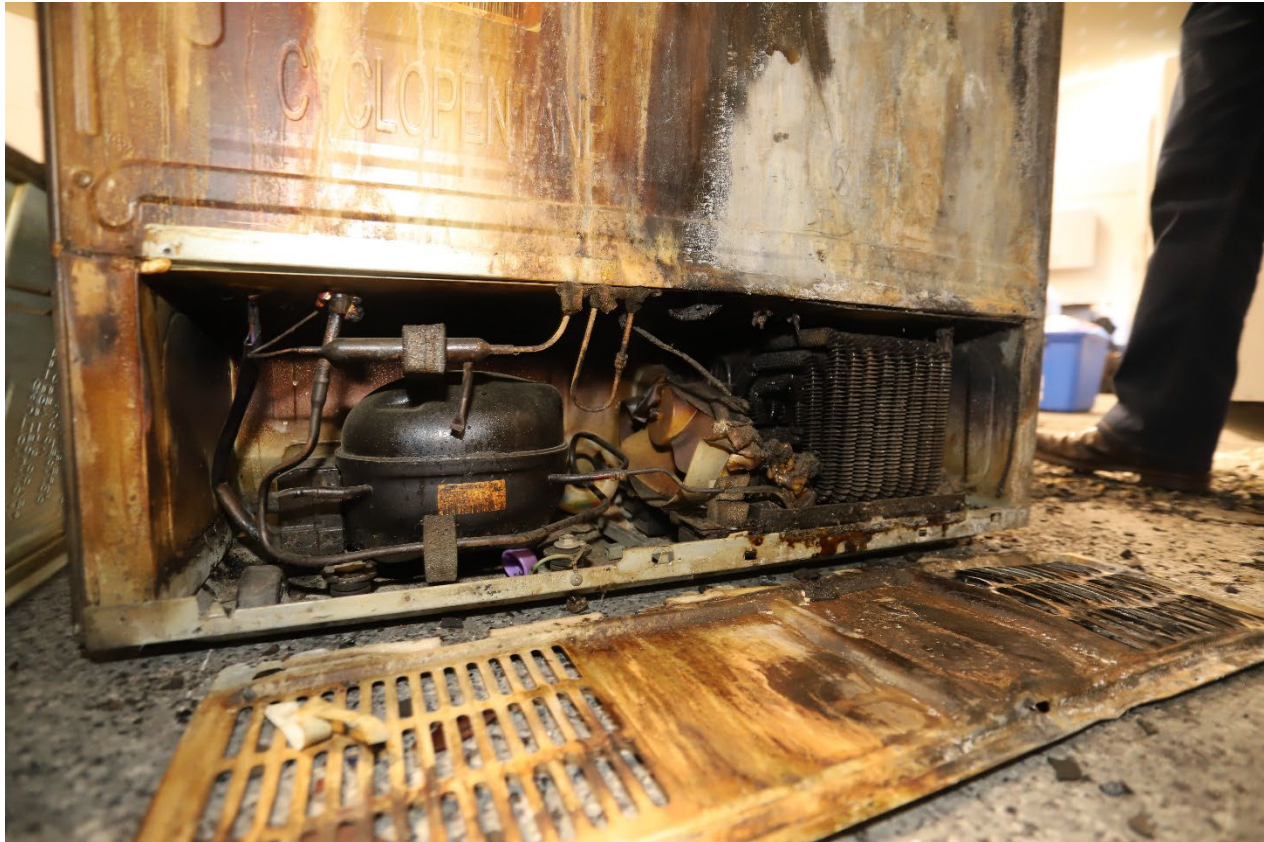
The refrigerator from the Residence was examined. The refrigerator was installed along the south wall of the kitchen on the opposite side of the Bedroom #4 wall where a hoverboard was reportedly found. The damage to the refrigerator was consistent with attack by an external fire. There was no evidence of a fire originating in the refrigerator (Figure 15)

**Figure 15. Refrigerator compressor and condensing coil (15082 BNS 6-088).**

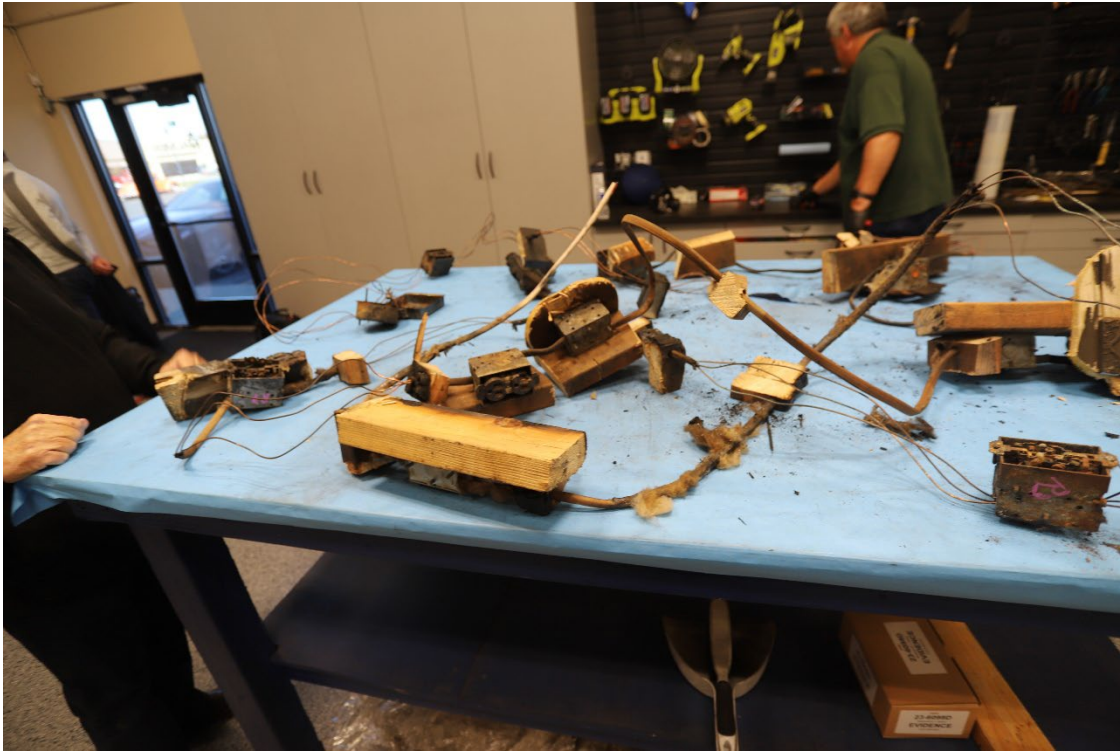
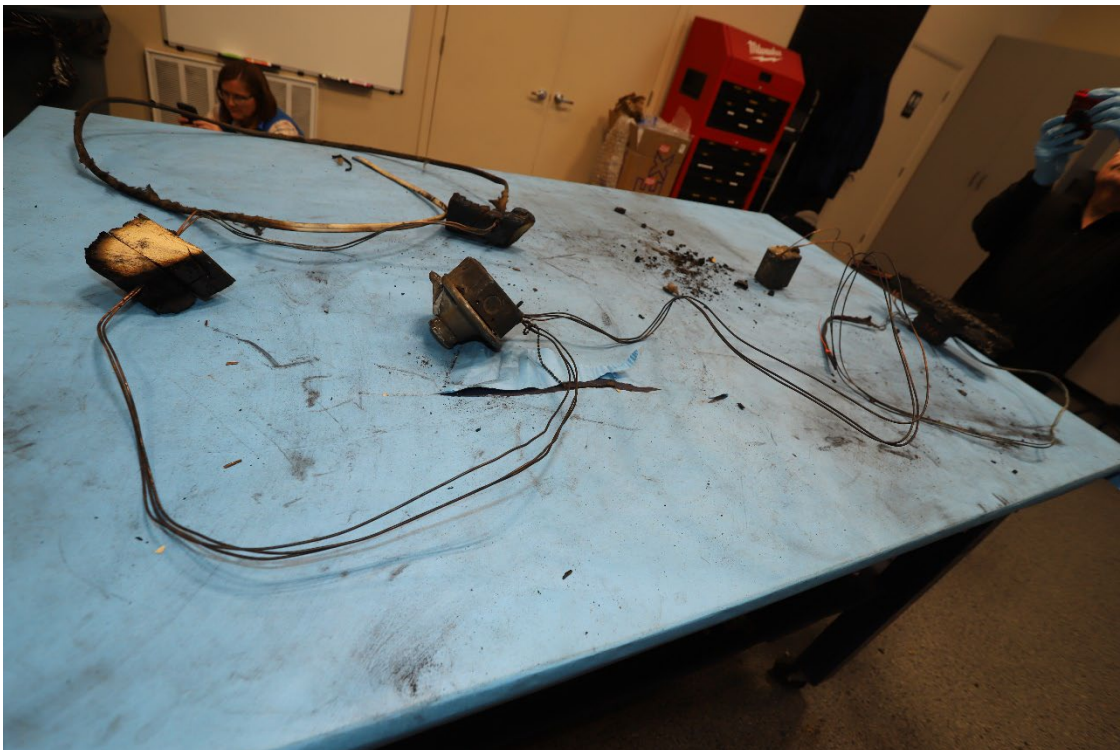
The entire branch circuit from within Bedroom #4 was examined (Figures 16 and 17). Despite much of the electrical insulation on the branch circuit conductors having been consumed by the fire, there was no evidence of electrical arcing on any of the conductors installed in Bedroom #4.

**Figure 16. Branch circuit from southern portion of Bedroom #4 (15082 BNS 6-133).**

**Figure 17. Branch circuit from northern portion of Bedroom #4 (15082 BNS 6-215).**
